Snake ESU/DPS update: Tucannon
Habitat Programmatic and Asotin

Umbrella project (#2010-077-00)

Asotin Creek Intensively Monitored Watershed

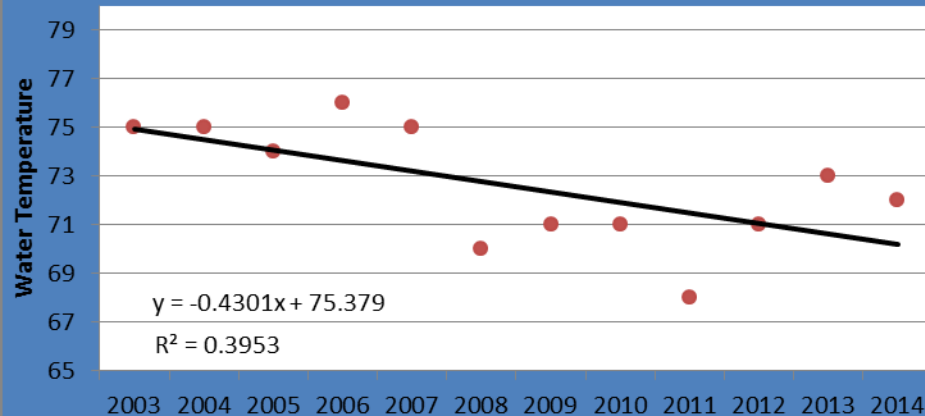
Tucannon Instantaneous Maximum Water Temperature at Marengo

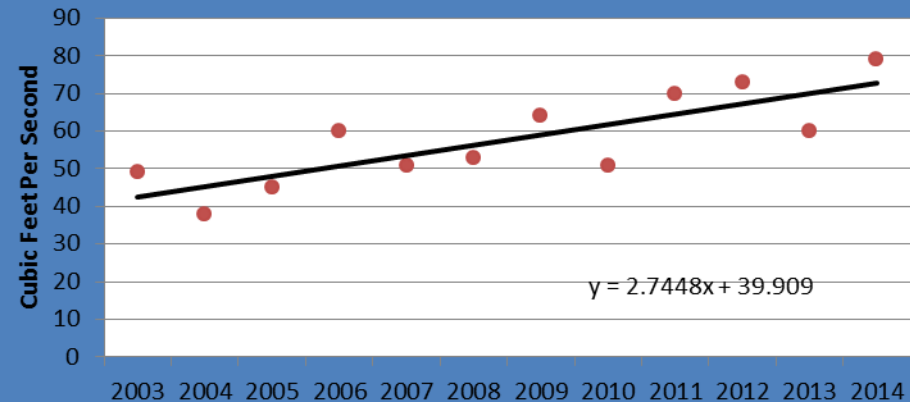
Tucannon River Instantaneous Minimum Flow at Marengo

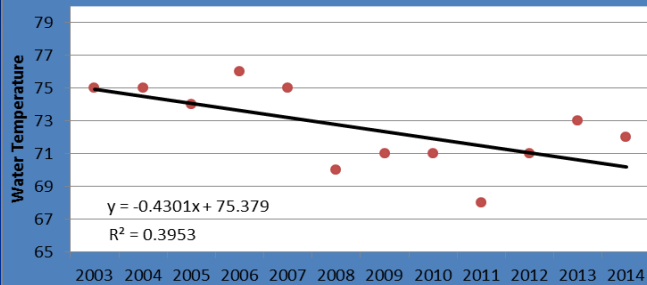
Tucannon Instantaneous Maximum Water Temperature at Marengo

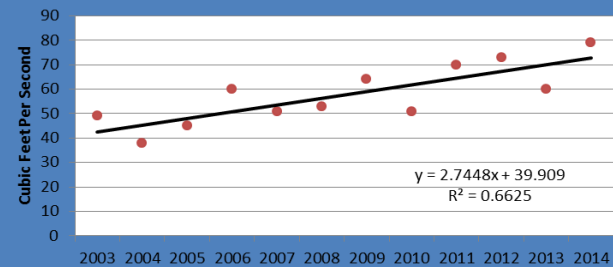
Tucannon River Instantaneous Minimum Flow at Marengo

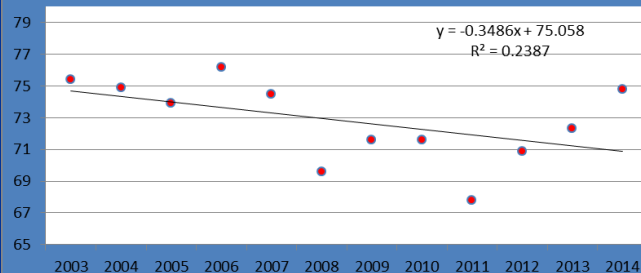
Touchet River Instantaneous Maximum Water Temperature above Dayton

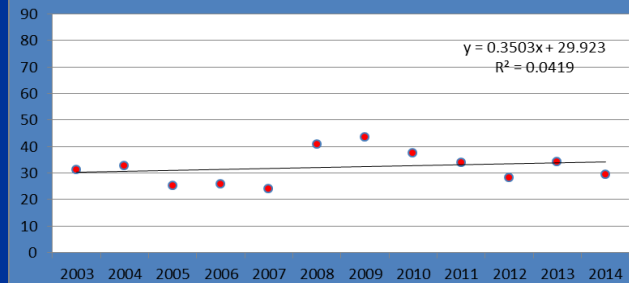
Touchet River Instantaneous Minimum Flow above Dayton

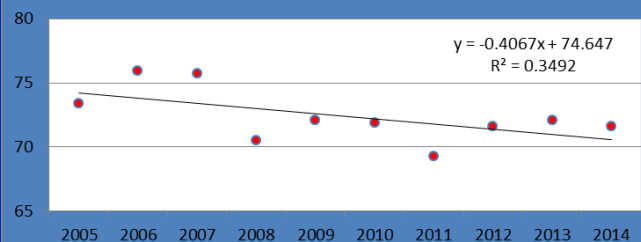
Asotin Creek Instantaneous Maximum Water Temperature above George Creek

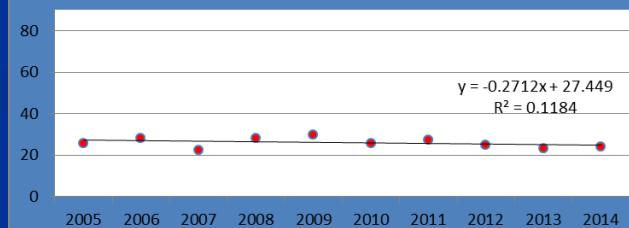
Asotin Creek Minimum Instantaneous Flow Above George Creek

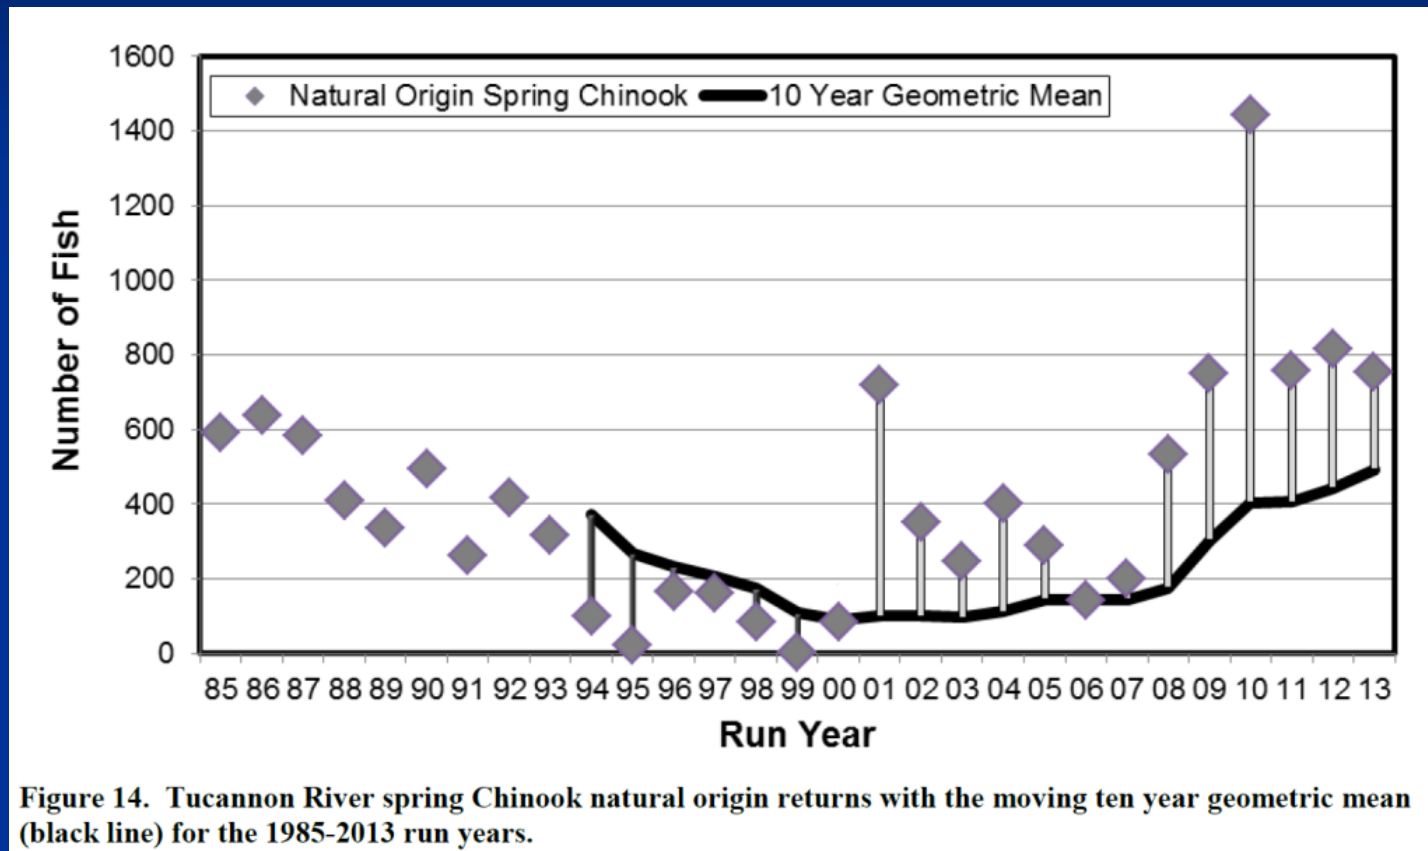
Figure 14. Tucannon River spring Chinook natural origin returns with the moving ten year geometric mean (black line) for the 1985-2013 run years.

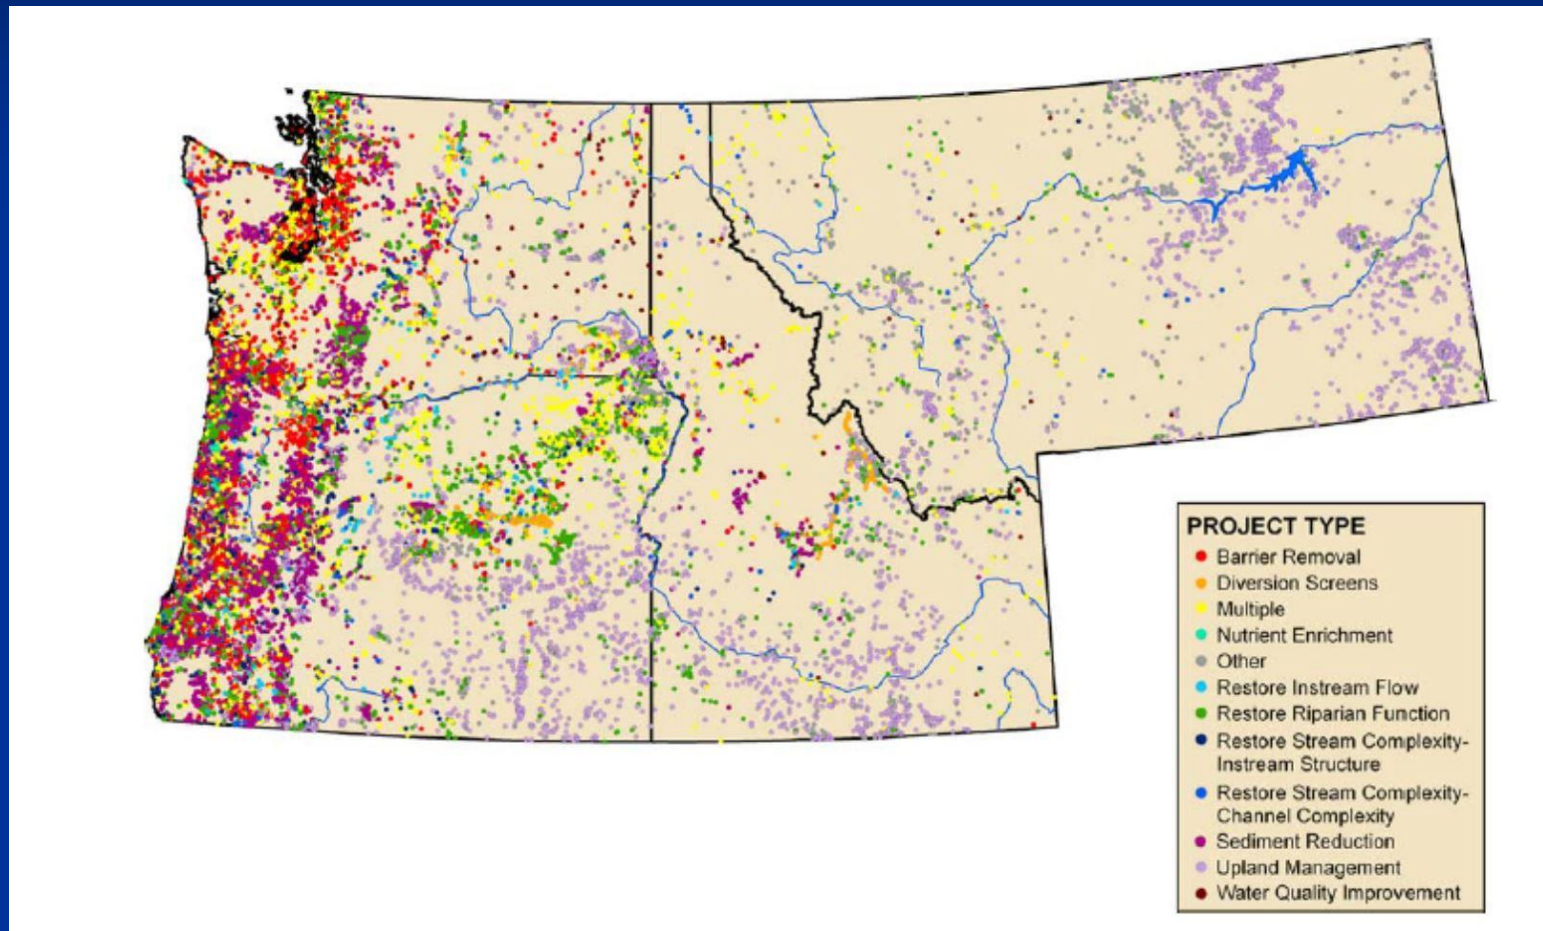
Distribution and type of river restoration projects in the Pacific Northwest (35,696 projects; Katz et al. 2007).

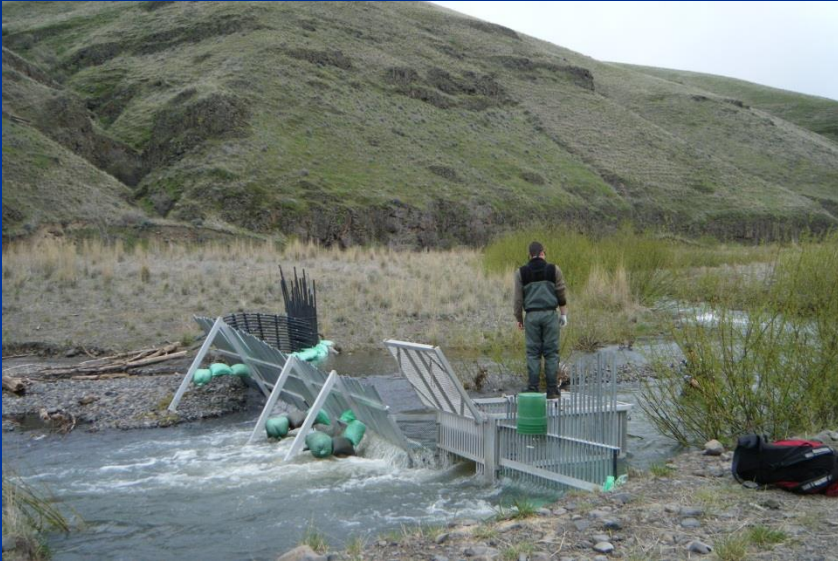
Adult weir

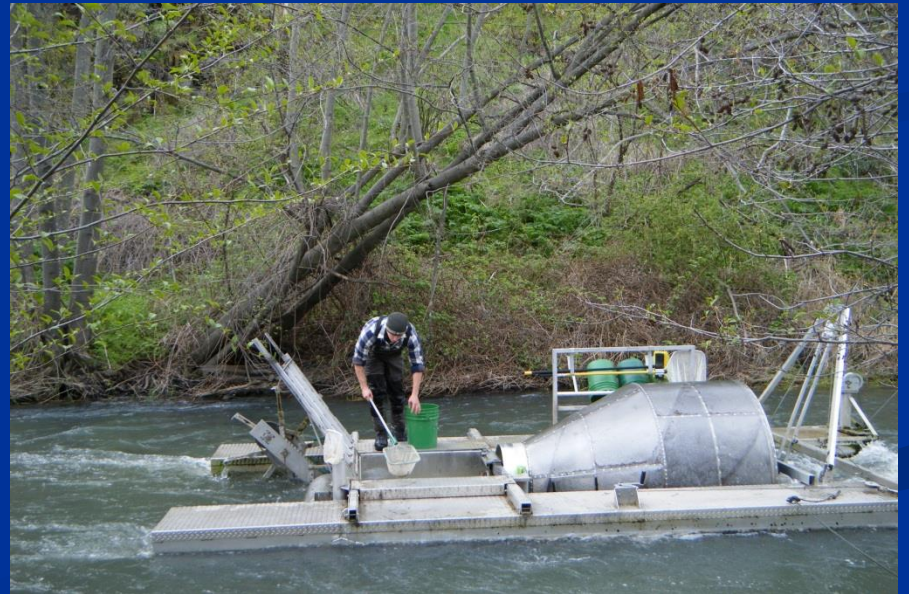
Smolt trap

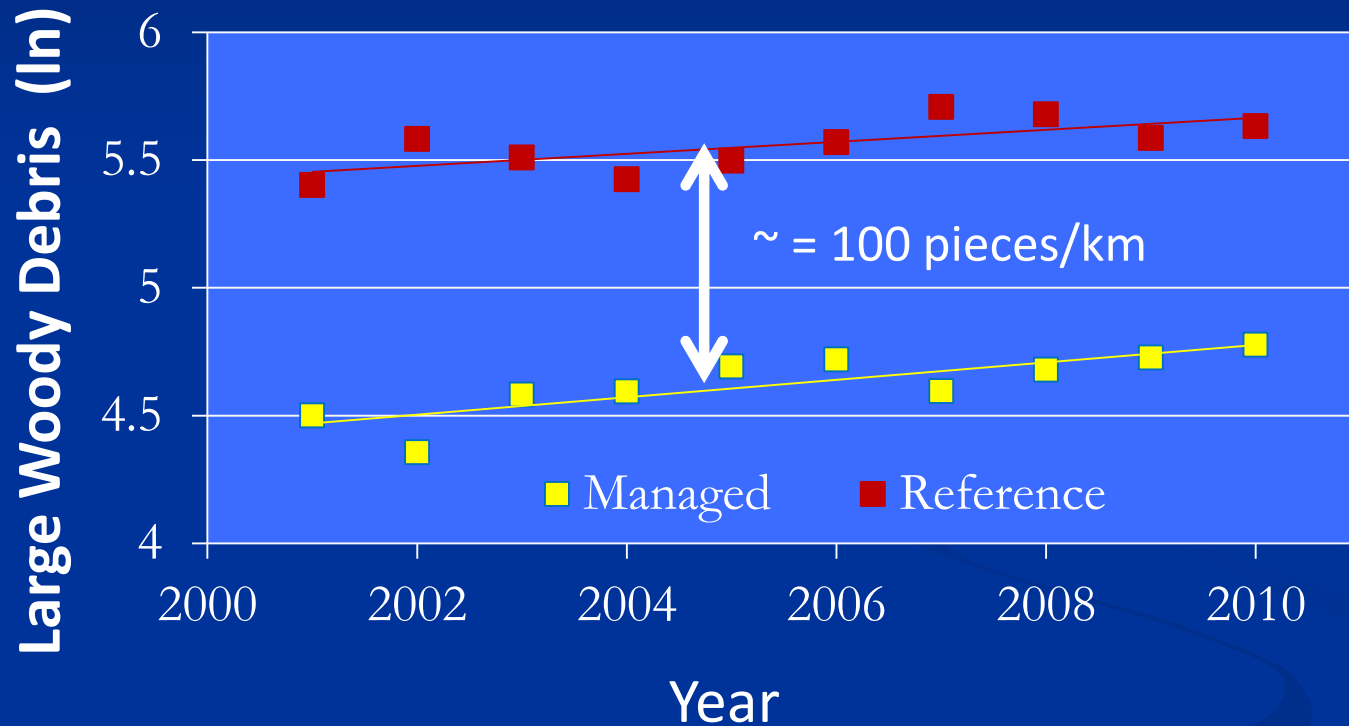
Median wood counts (ln) in managed and reference conditions across the interior Columbia Basin (Roper et al. 2011; AFS symposium in Seattle, WA).

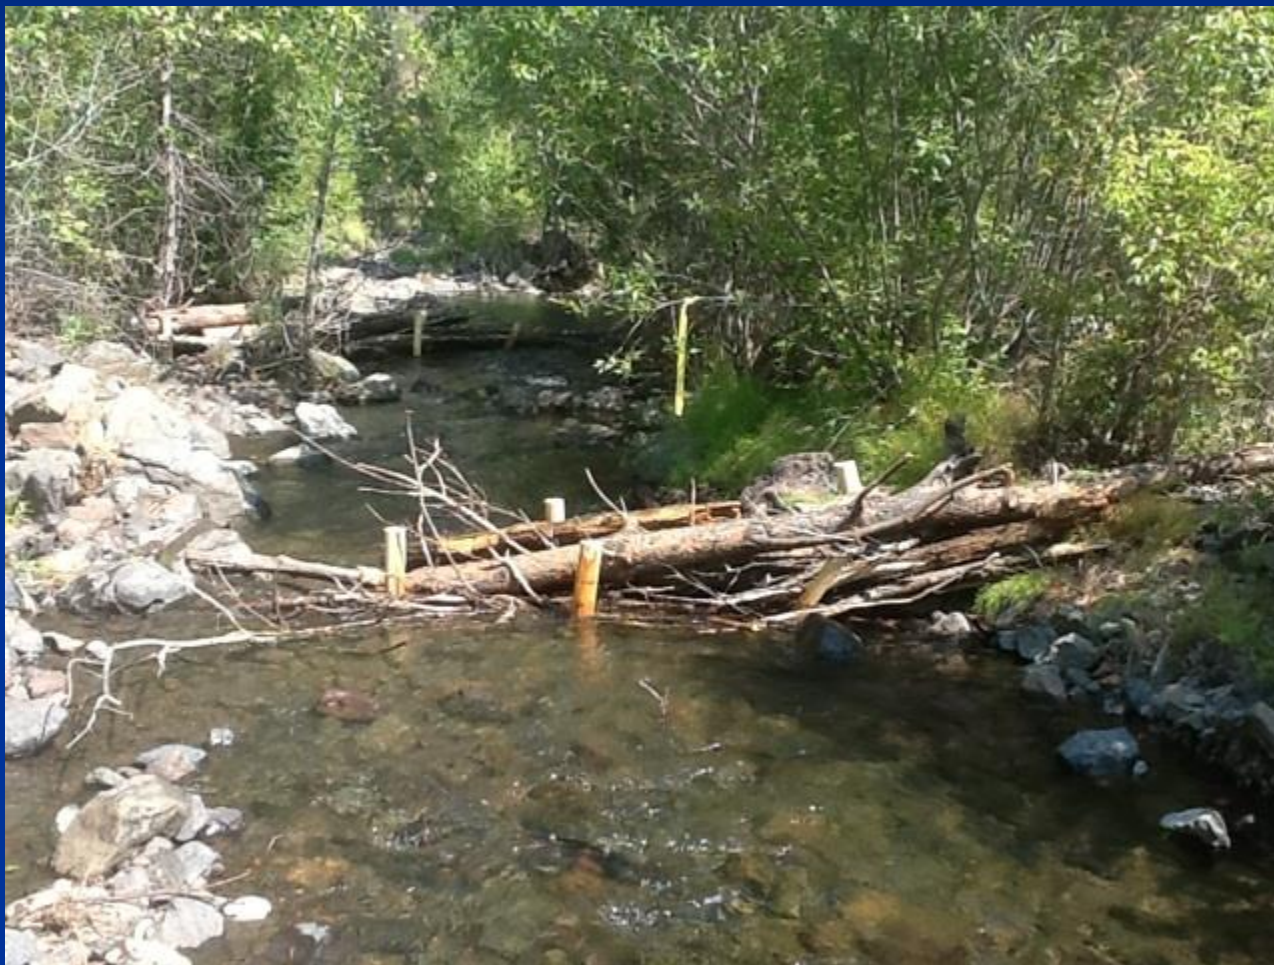
Deflector PALS

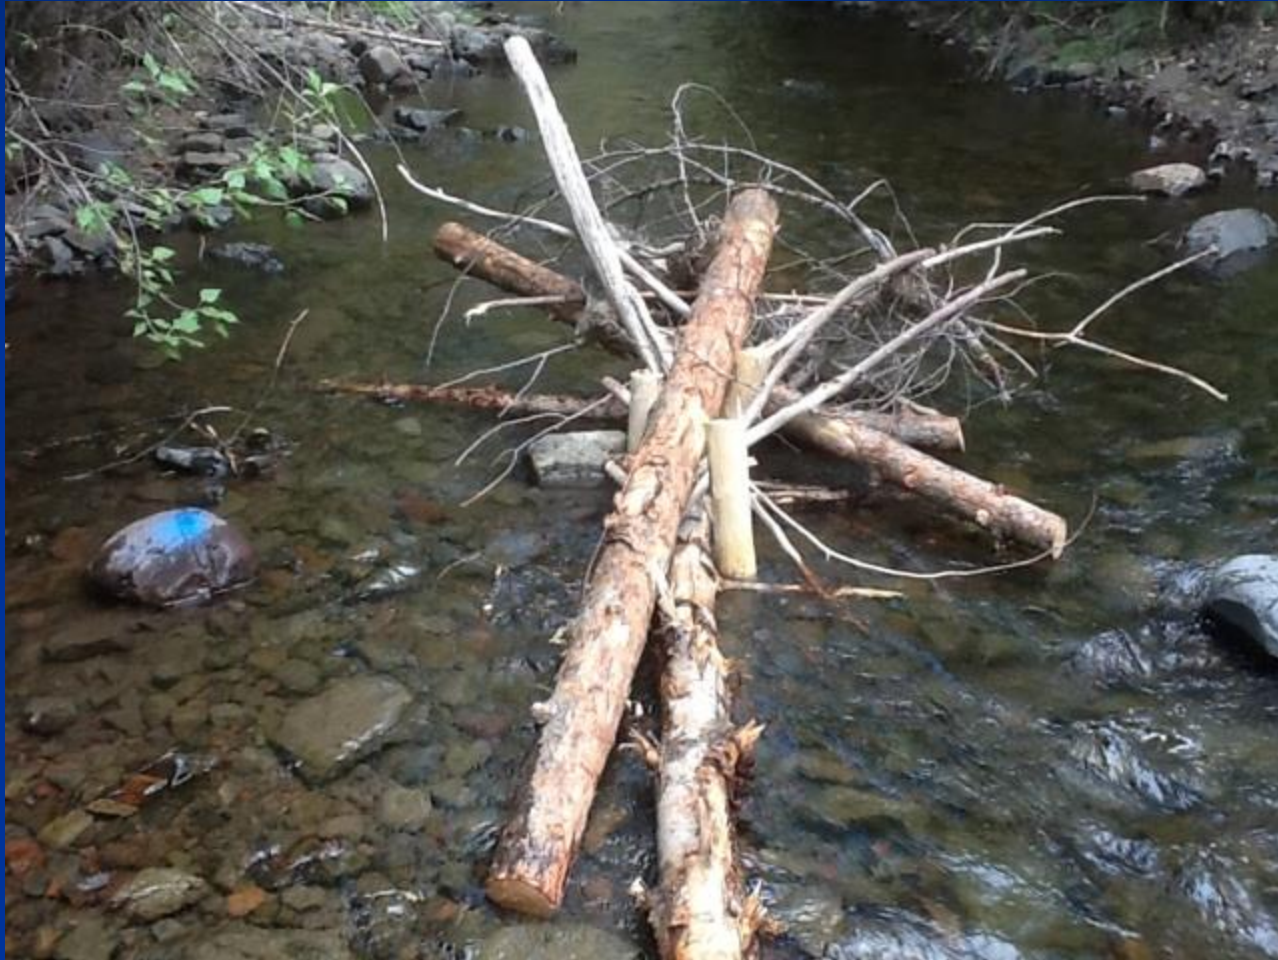
Mid-Channel PALS

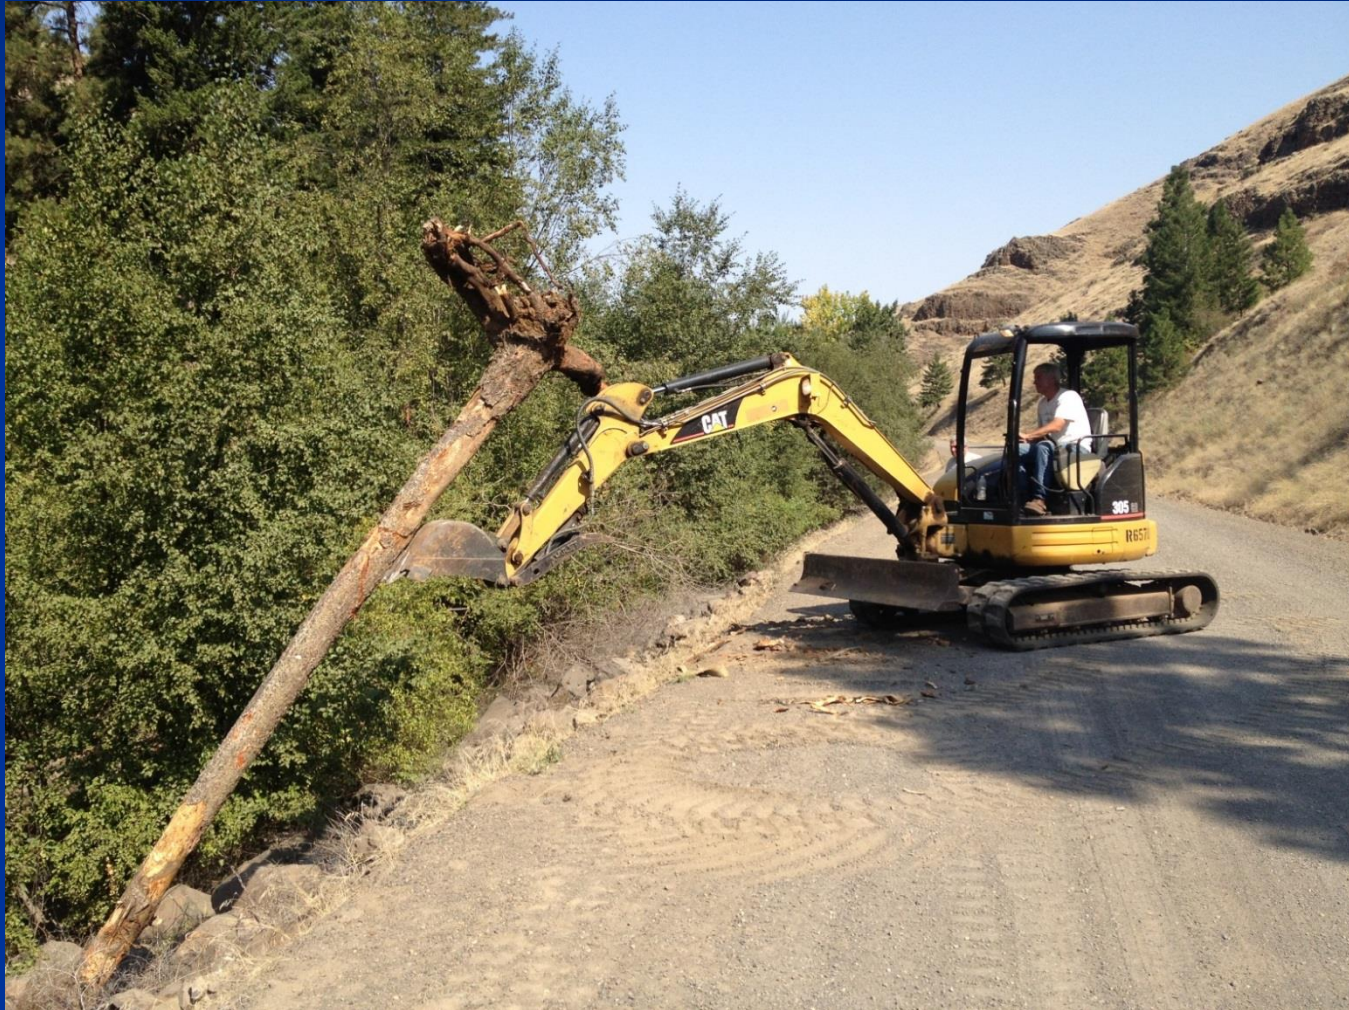
Key LWD

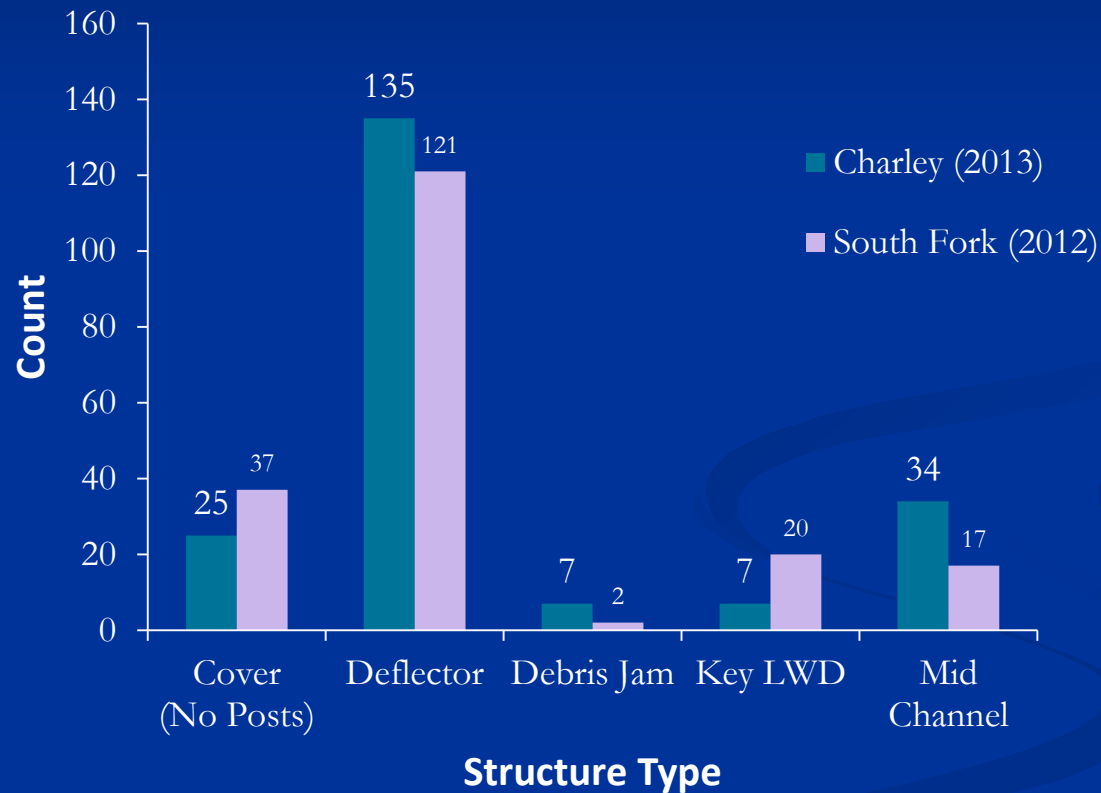
Number and type of structures built in South Fork Asotin Creek (2012; n = 197) and Charley Creek (2013; n = 208).

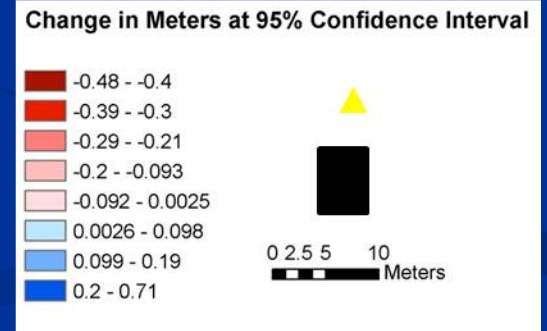
Geomorphic change detection in North Fork trial restoration site: 2012-2011.

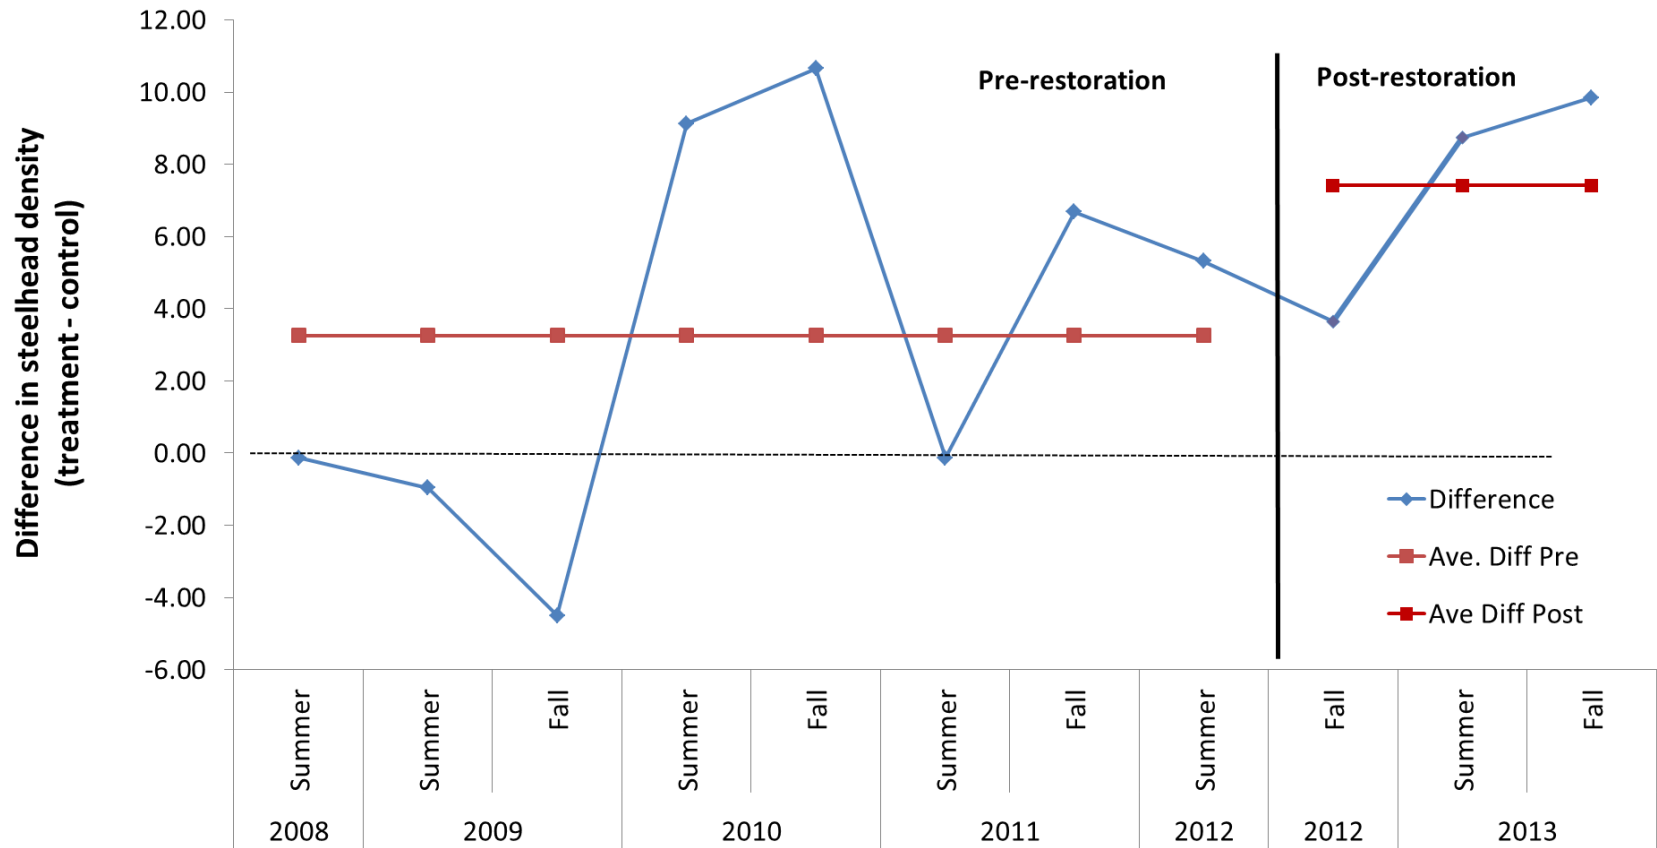
Difference of juvenile steelhead density between South Fork treatment and all controls combined (Pre P = 0.12).
